West gate, March 2001

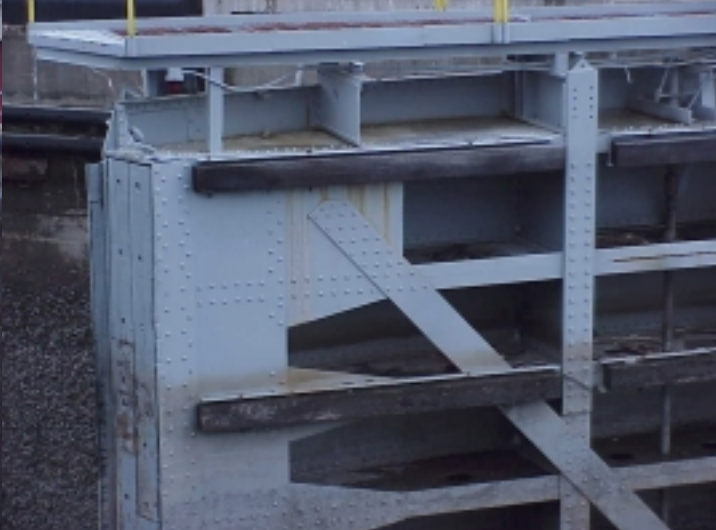
Atmospheric area has rust stains bleeding from joints.

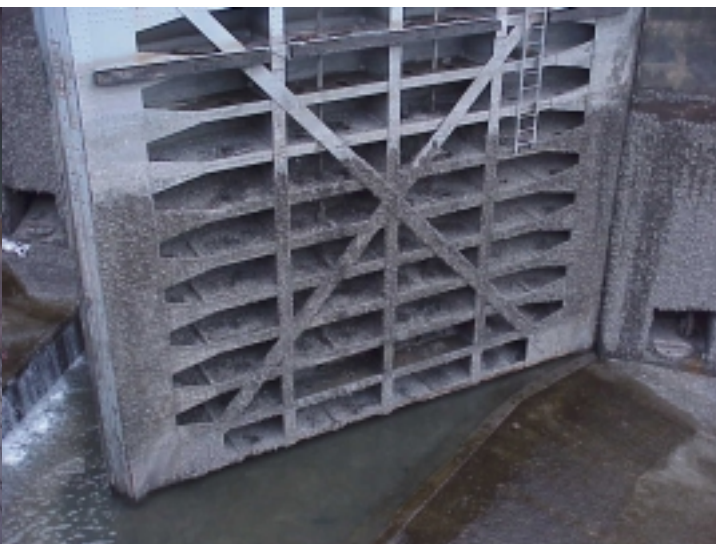
Zebra mussels on lower portion of gate.

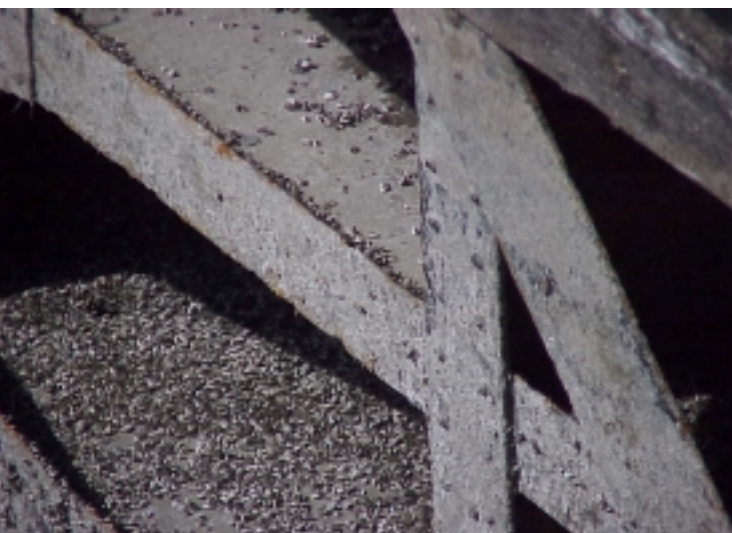
Corrosion due to poor application on edges.

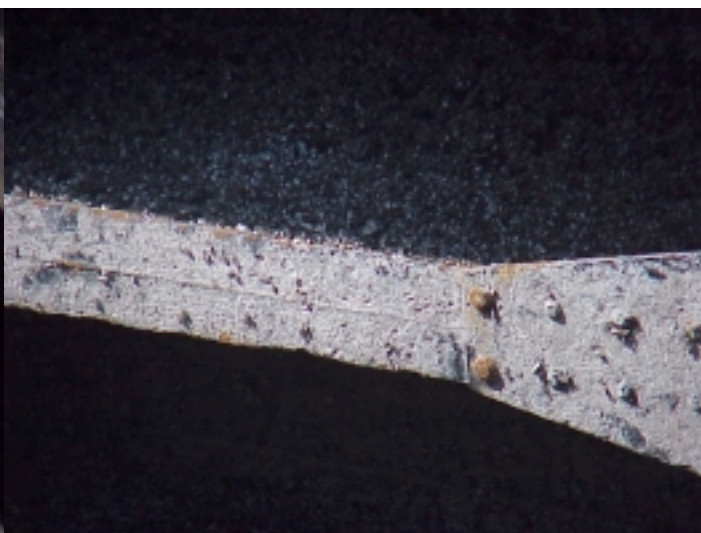
Most corrosion is application related.
